Navajo Abandoned Uranium Mine

Site Screen Report

Mine Name: **Jack Daniels No. 4**Mine ID: **544**

August 2011

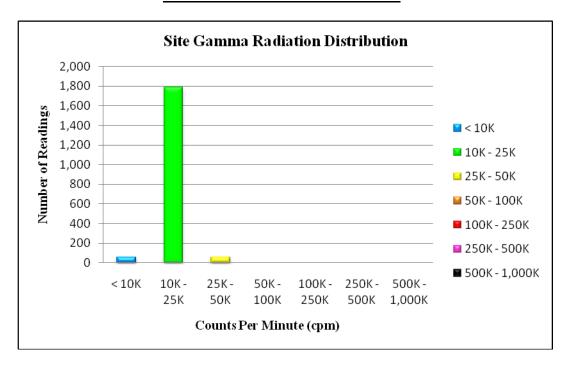
Distribution Chart and Statistics:

Site Gamma Radiation Statistics				
Number of Readings	1,902			
Minimum (cpm)	6,123			
Maximum (cpm)	42,403			
Mean (cpm)	13,511			
Median (cpm)	12,526			
Standard Deviation	4,090

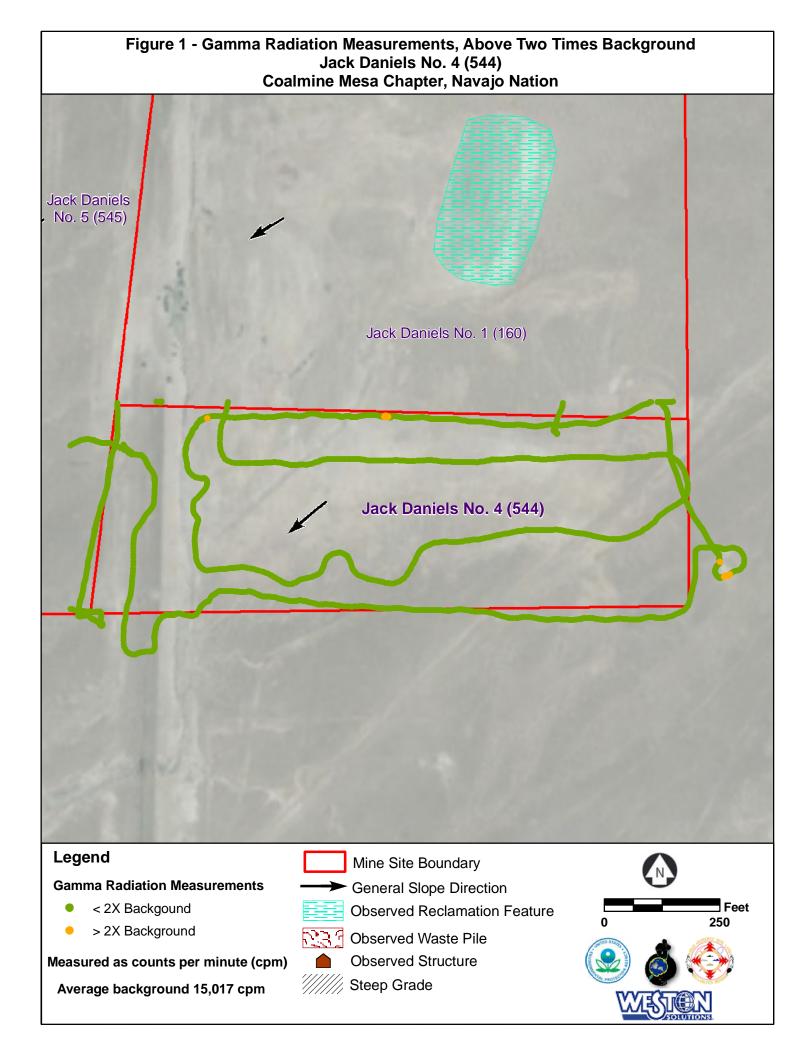
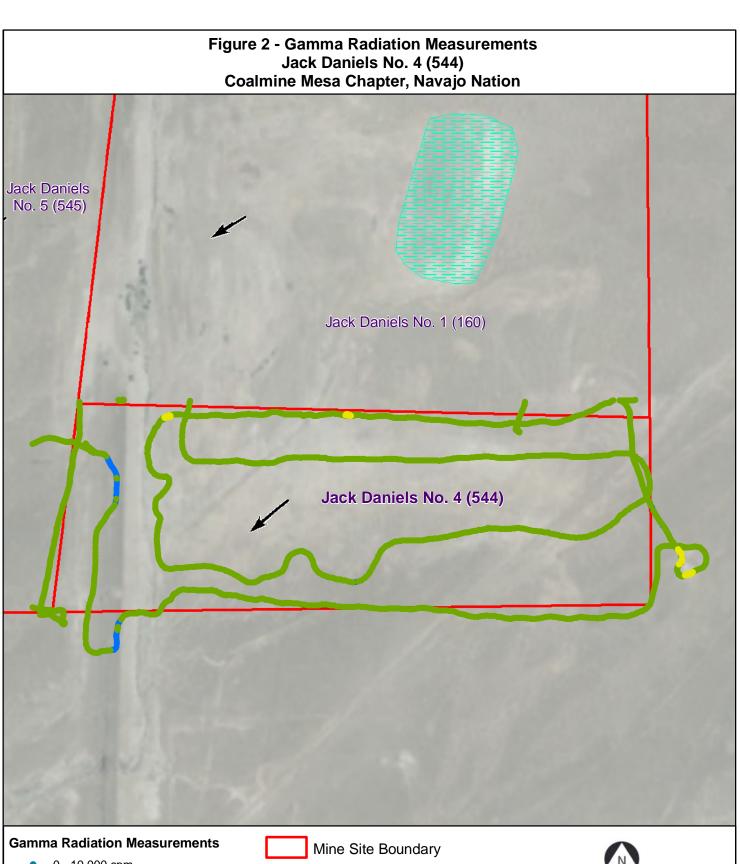
A total of 1,902 gamma radiation measurements were collected from the mine site, ranging from 6,123 cpm to 42,403 cpm. The measurements are represented in Figures 1 and 2.
